CORROSION IN AUTOMATIC SPRINKLER SYSTEMS

This data sheet provides recommendations that are intended to address the prevention and control of corrosion in automatic sprinkler system piping.

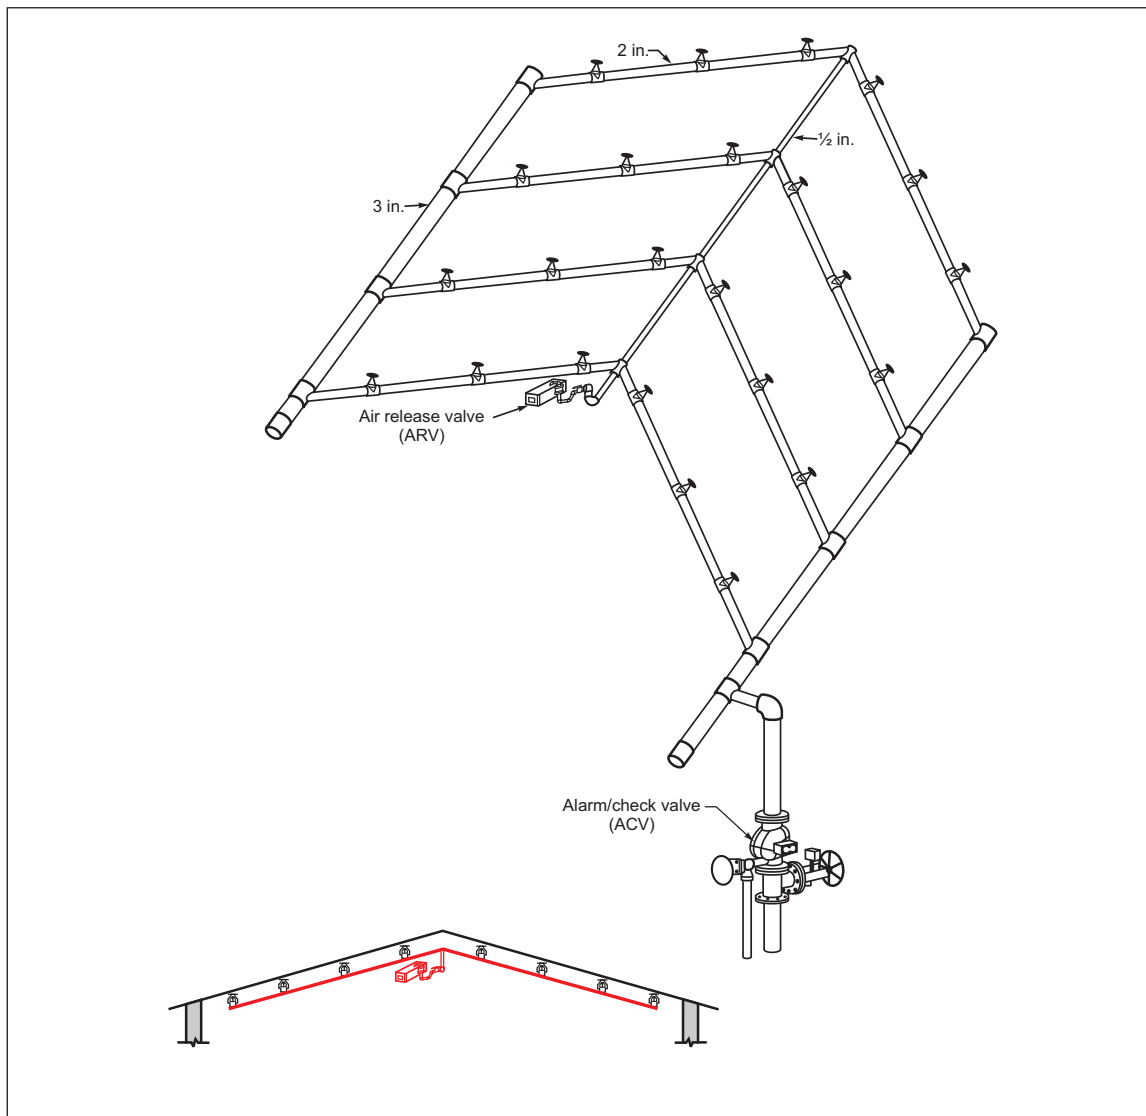
Fig. 1. Example of wet sprinkler piping arranged with an automatic air-release valve

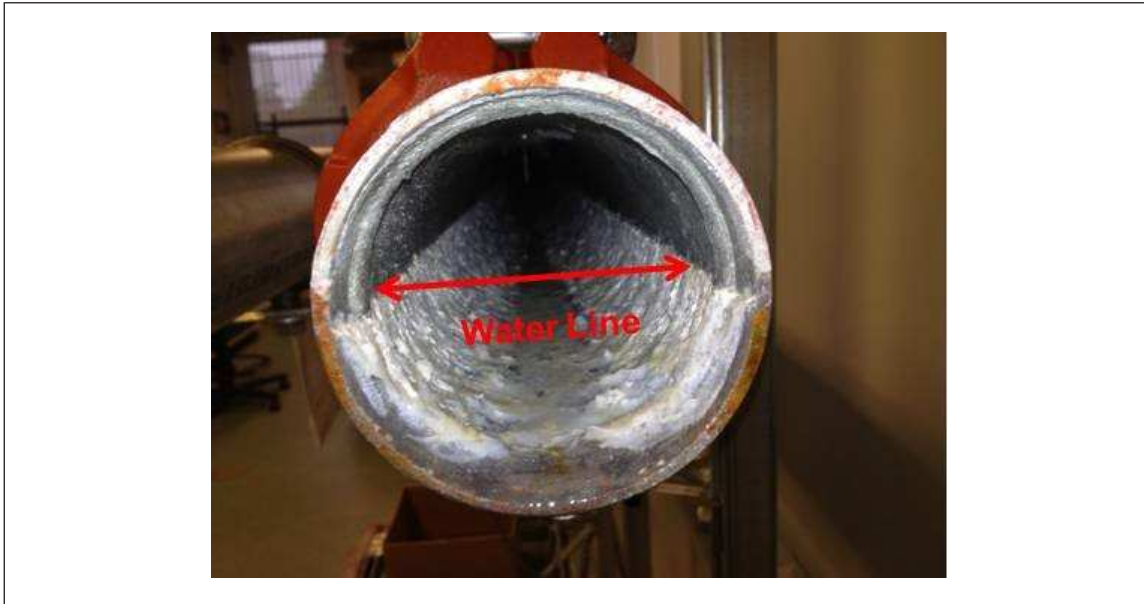
Figures 4a and 4b are photographs of galvanized steel pipe half-filled with tap water in house air (4a) and in compressed nitrogen (4b) after nearly six weeks' exposure. Whitish zinc corrosion products covered the bottom half of the house air-filled pipe in Figure 4a, but only limited zinc corrosion products covered the bottom half of the compressed nitrogen-filled pipe (Figure 4b). This result indicates that compressed nitrogen can reduce corrosion of galvanized steel pipe containing trapped water.

Fig. 4a. Galvanized steel pipe half-filled with tap water in house air after nearly six weeks' exposure

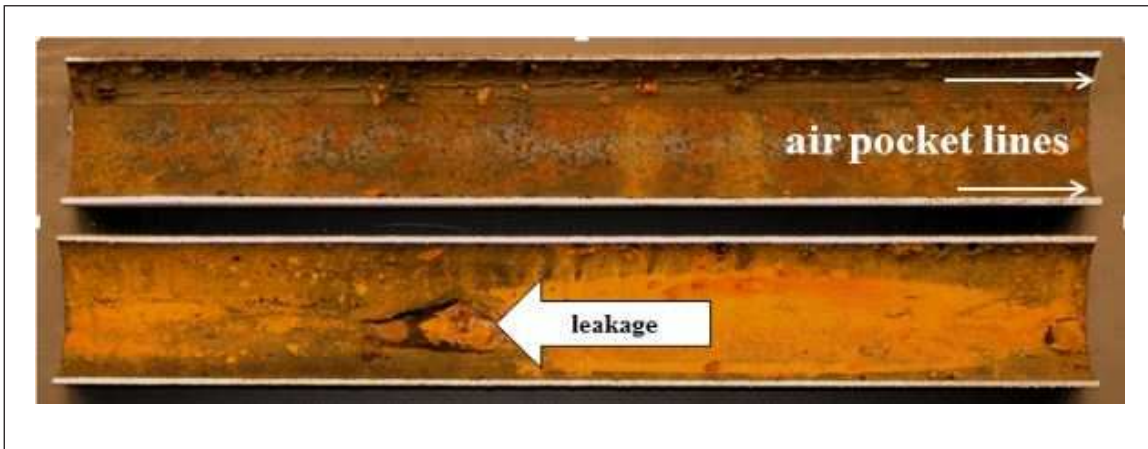
Figure 5 shows the section of a pipe in which the air gap filled approximately 40% of the volume in a wet pipe system, providing the oxygen source for steel pipe corrosion. The through-wall leakage site is indicated and the two parallel lines point to the air pocket boundary in the pipe. Note the significant tuberculation, corrosion, and deposit buildup in the bottom half of the pipe. The arrow points to a large tubercle, beneath which was the site of the leakage.

Fig. 5. Leakage section of a pipe where the air gap filled approximately 40% of the volume in a wet-pipe system

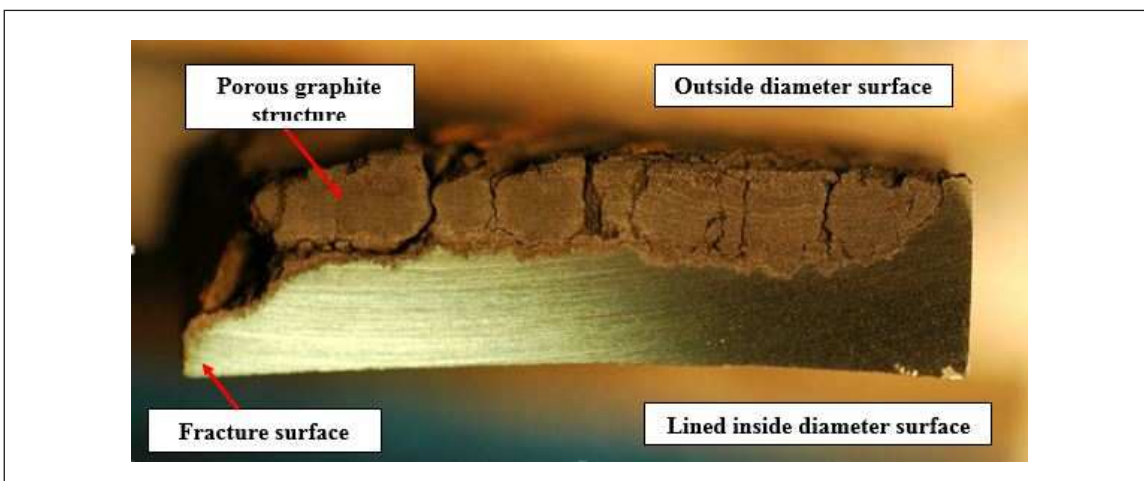
Figure 8 shows a cross section for part of the water main in Figure 7. It is noted that almost the entire wall thickness of the pipe has been penetrated by graphitic corrosion attack at the far left fracture surface, while the pipe's inside diameter surface with cement lining is in good condition.

Fig. 8. Cross section for part of the water main in Figure 7

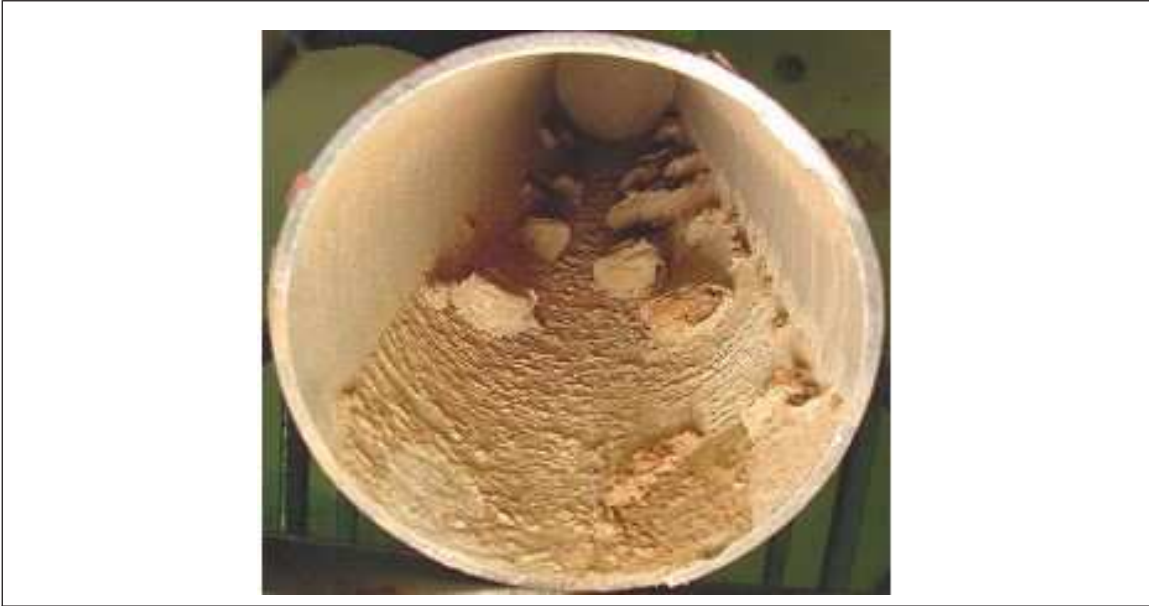
Figure 9a shows tubercles and and Figure 9b shows pinhole leakage (circled) in galvanized steel sprinkler pipe from dry-pipe systems.

Fig. 9a. Tubercles that formed inside a galvanized steel sprinkler pipe (4 in. [10 cm] diameter)

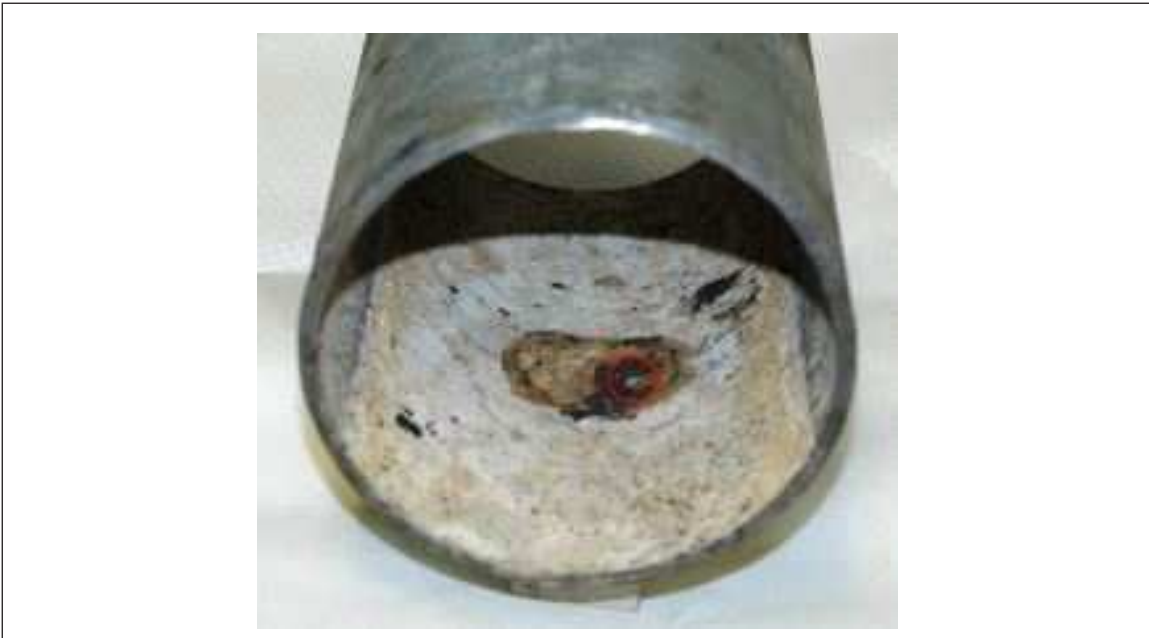
Fig. 9b. Corrosion at the base of a tubercle, which ultimately led to through-wall leakage

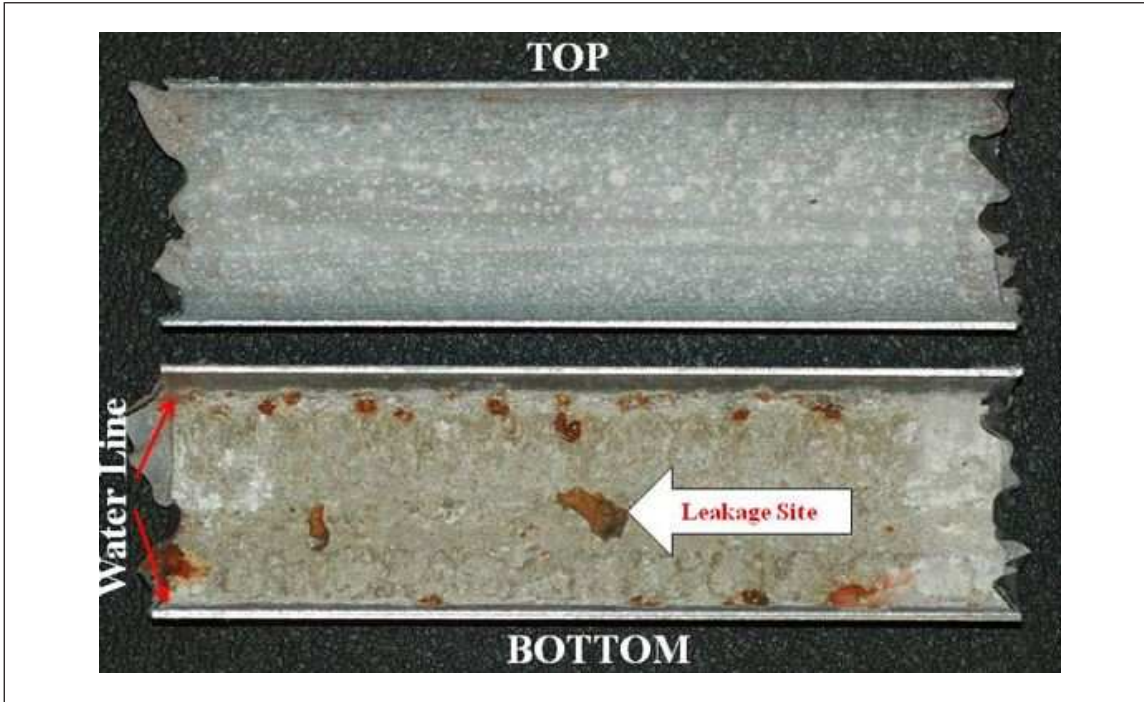
Figure 10 shows NPS 4 galvanized steel pipe (4.5 in. [11.4 cm] OD) with through-wall leakage. Residual water filled about 40% of the pipe's volume in service. Under the waterline, white rust (zinc corrosion) and well over a dozen reddish-brown tubercles of various sizes are evident on the bottom half of the pipe. The corrosion remains localized. The top half of the pipe is free of corrosion while the bottom half has significant corrosion.

Fig. 10. NPS 4 galvanized steel pipe (4.5 in. [11.4 cm] OD) with through-wall leakage

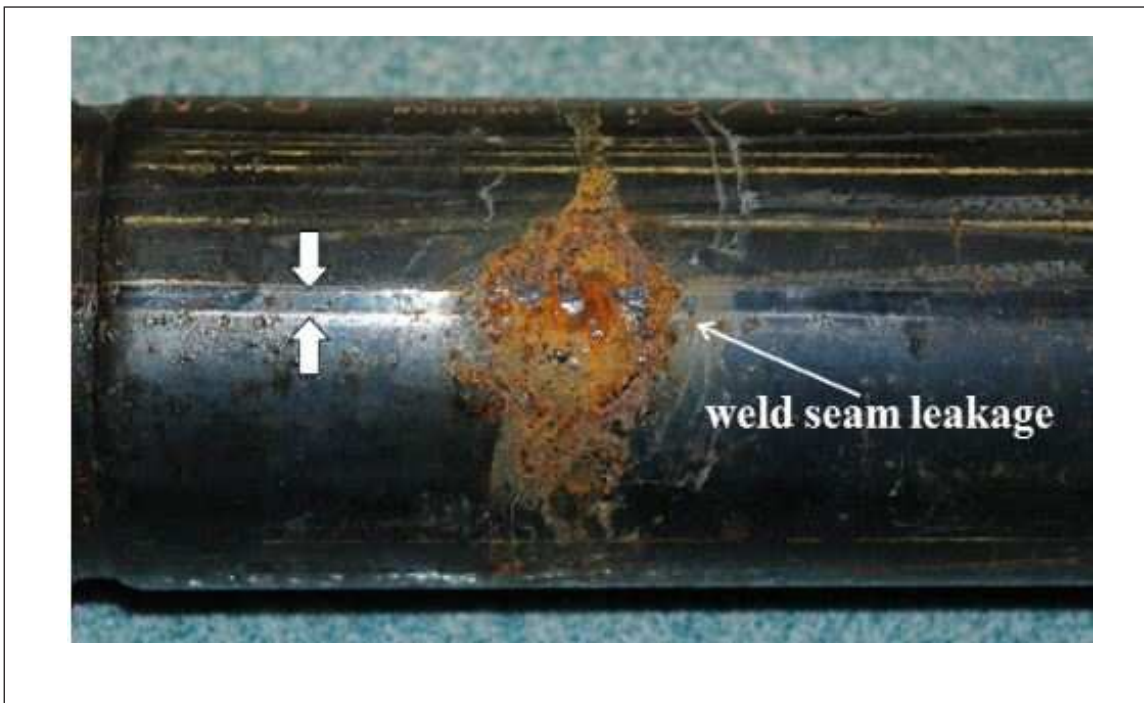
Figures 11a and 11b show leakage on an NPS 2½ steel sprinkler pipe in a wet pipe system. The weld seam leakage site and the location of the weld seam are indicated by arrows in Fig. 11b. Leakage on an NPS 2½ steel sprinkler pipe in a wet pipe system after removal of corrosion products; preferential attack surrounding the weld seam is severe

Fig. 11a. Leakage on an NPS 2½ steel sprinkler pipe in a wet pipe system; arrows indicate the weld seam leakage site and the location of the weld seam

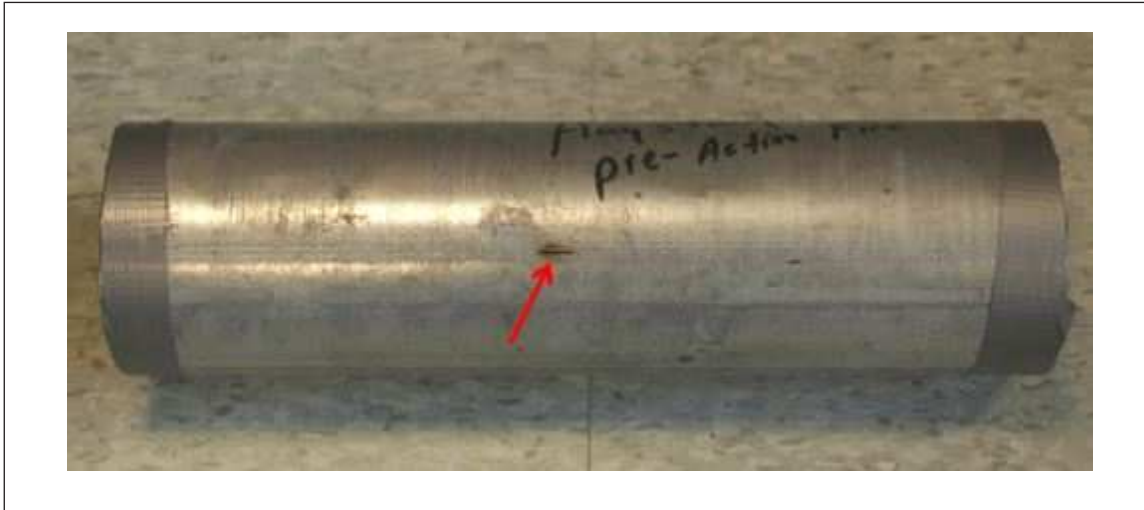
Figure 13 shows grooving corrosion of a longitudinal through-wall leakage in a galvanized steel pipe along its weld seam in a preaction system. The leak occurred beneath a large tubercle along the pipe's approximate 6 o'clock installed position. The arrow points a longitudinal through-wall leakage site on the pipe.

Fig. 13. Grooving corrosion of a longitudinal through-wall leakage in a galvanized steel pipe along its weld seam in a preaction

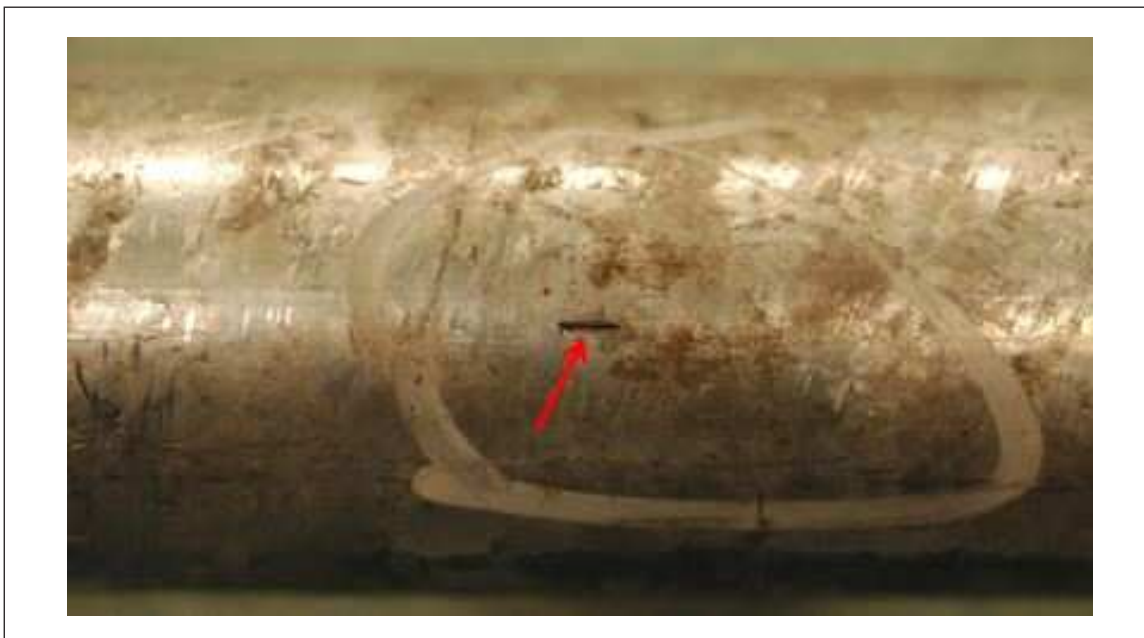
Figure 14 shows another preferential grooving corrosion attack surrounding the weld seam area for a preaction system, near the pipe's 6 o'clock (bottom) installed position.

Fig. 14. Preferential grooving corrosion attack surrounding the weld seam area for a preaction system, near the pipe's 6 o'clock (bottom) installed position

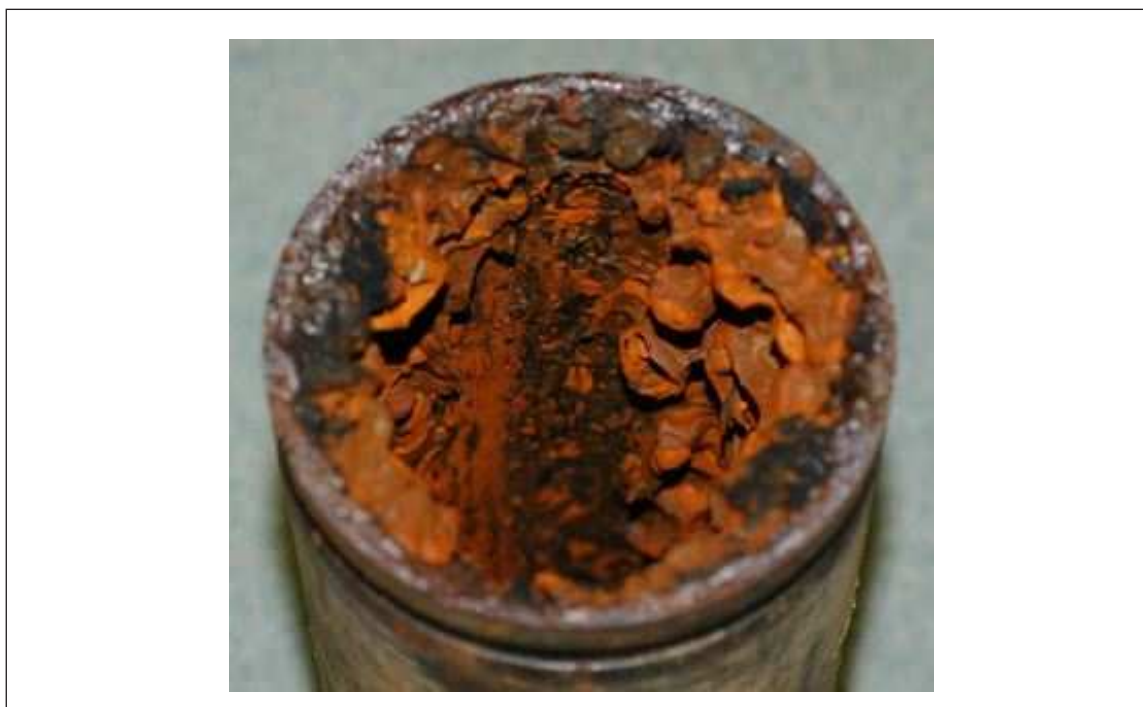
Figure 15 is an example of a 4 in. (10 cm) diameter corroded/leaking steel pipe with many tubercles formed inside the pipe. MIC caused by SRB was identified to be a likely contributing factor to the corrosion based on testing results of SRB immunoassay, lead acetate sulfide tests, water chemistry analyses, and corrosion/metallurgical evidence.

Fig. 15. Corroded steel pipe with many tubercles inside
